VEHICLE INSPECTION REPORT

NX180LG

Iveco Stralis 460

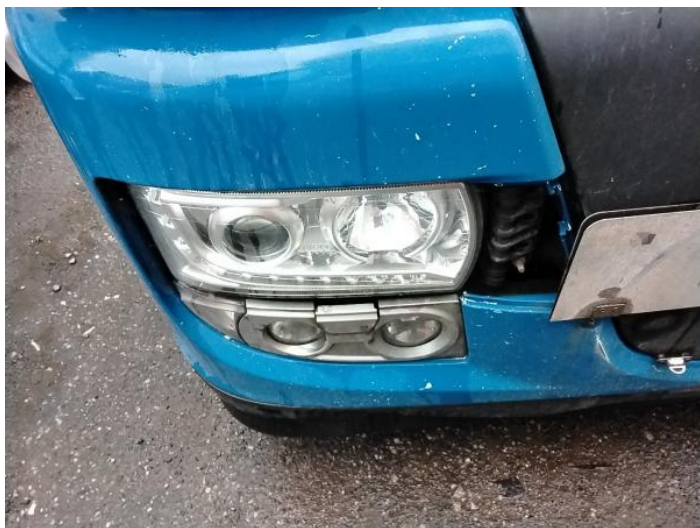
1: Bumper Front Moulding
Missing
Replace

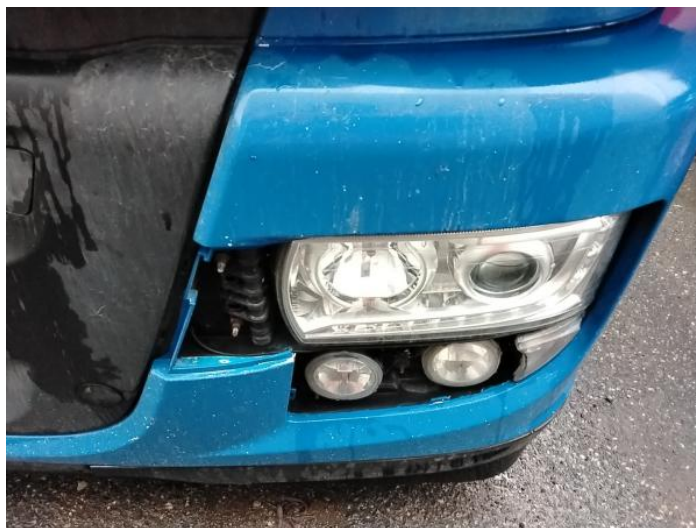
2: Bumper Front Moulding
Missing
Replace

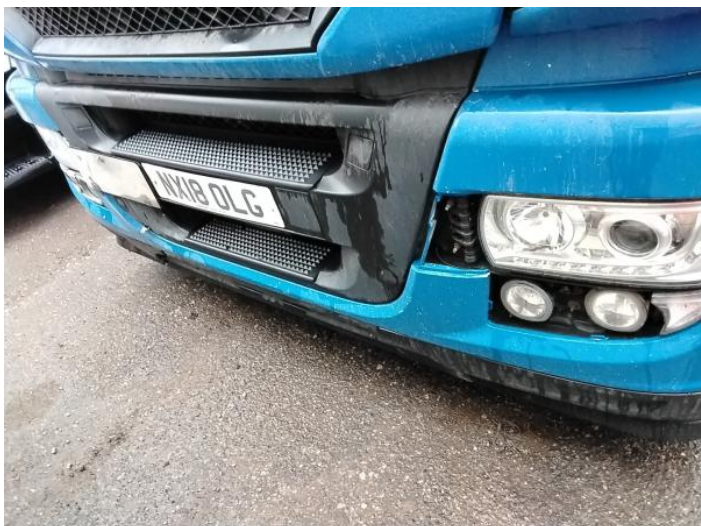
3: Bumper Front
Chipped
Multiple Chips

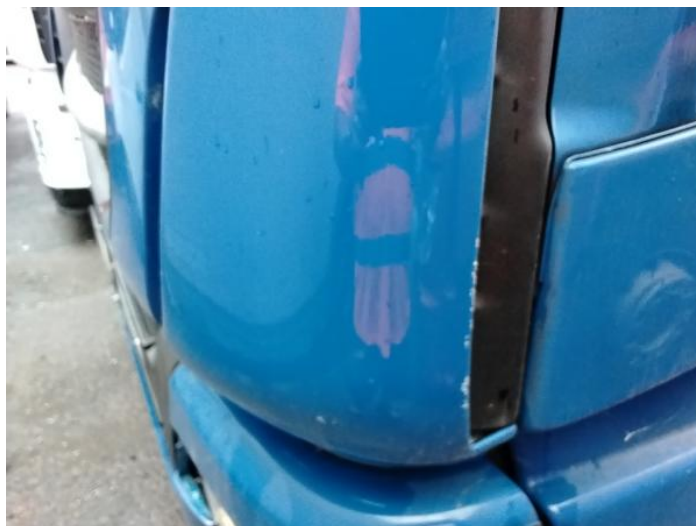
4: Panel Front
Scratched
Over 25mm Thru Paint

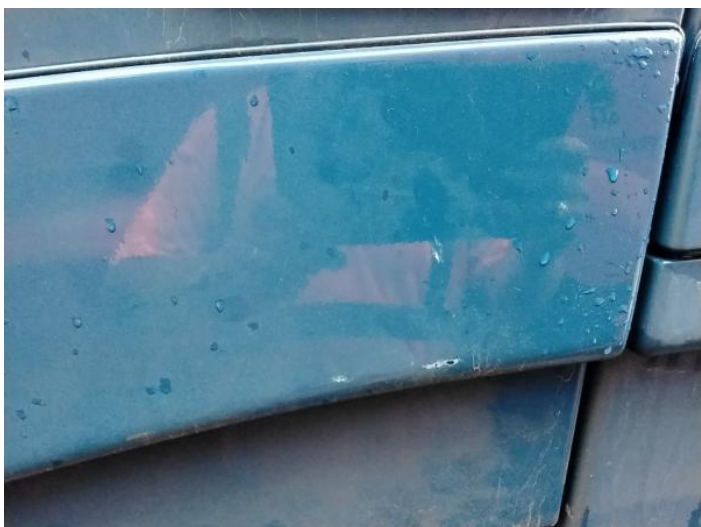
5: Door nsf
Scratched
Over 25mm Thru Paint

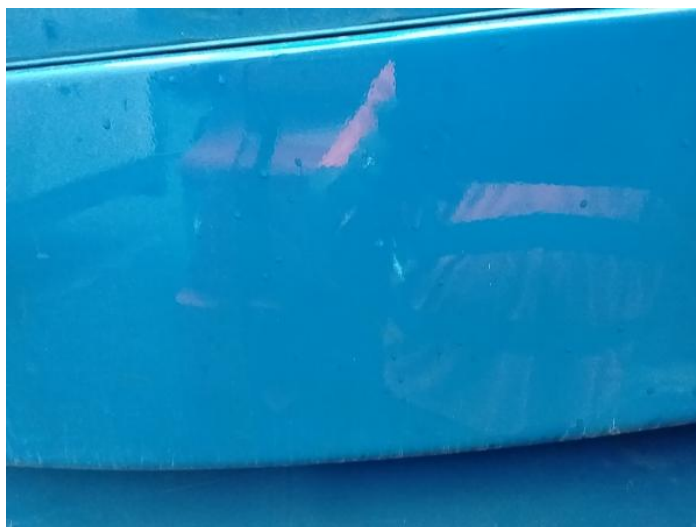
6: Door nsf
Scratched
Over 25mm Thru Paint

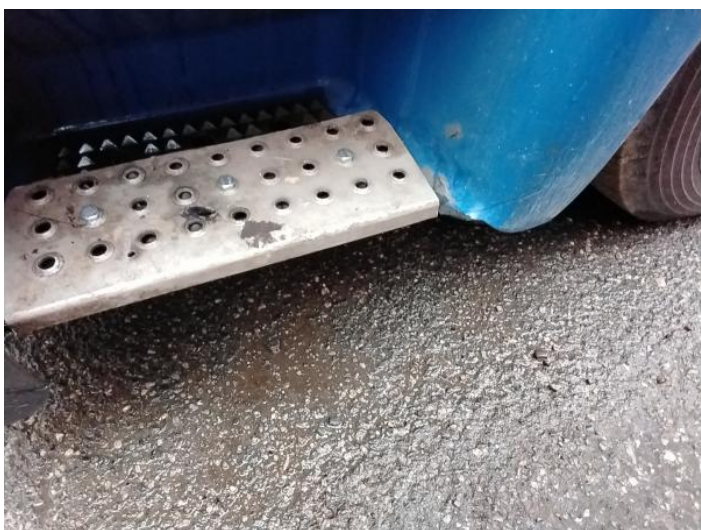
7: Bumper Front Moulding
Broken
Replace

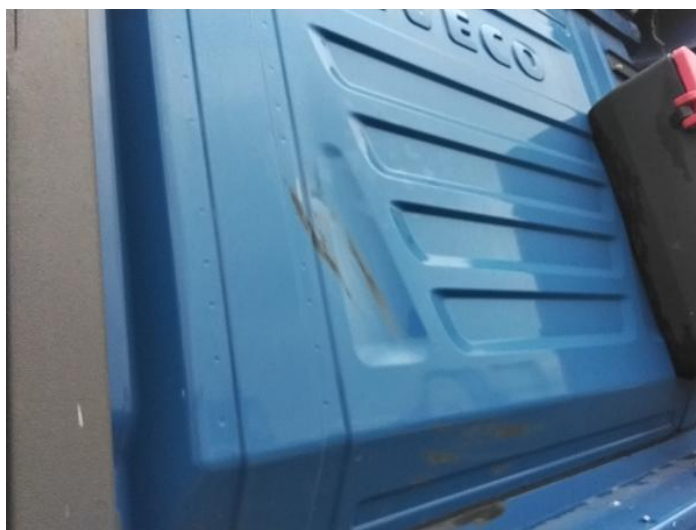
8: Panel Rear
Dented
Over 30mm

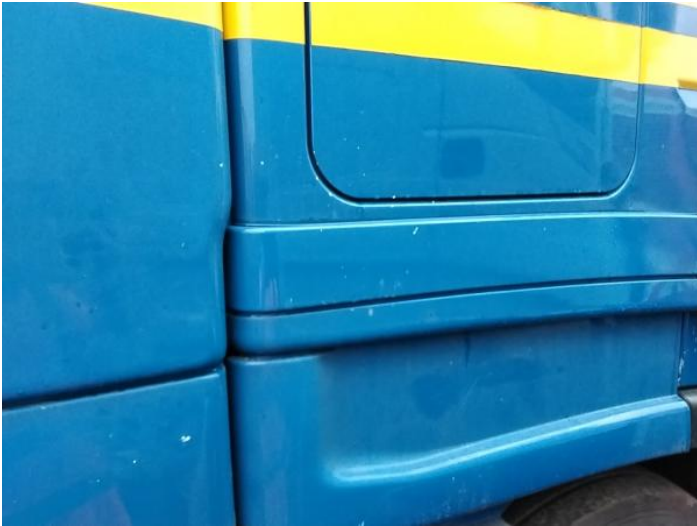
9: Qtr Panel osr
Chipped
Multiple Chips

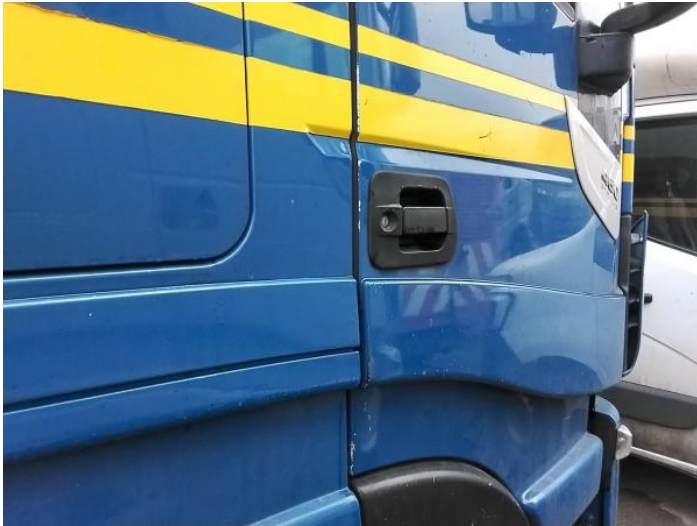
10: Door osf
Scratched
Over 25mm Thru Paint

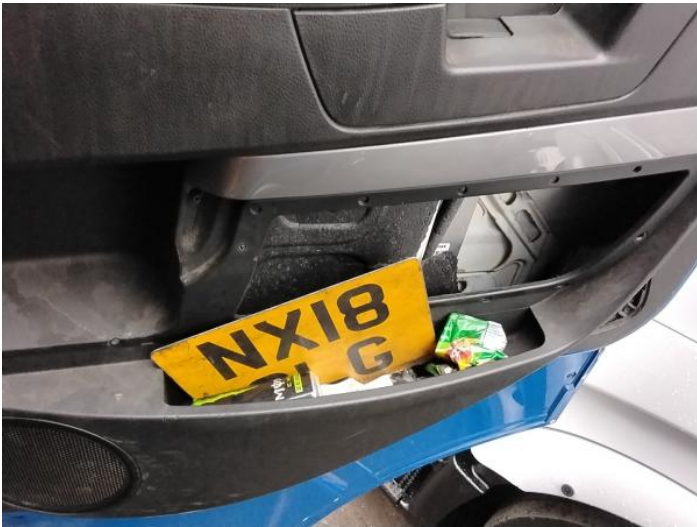
11: Door Pad osf
Broken
Replace
