VEHICLE INSPECTION REPORT

SG15ETF

Mercedes-Benz Antos 1843

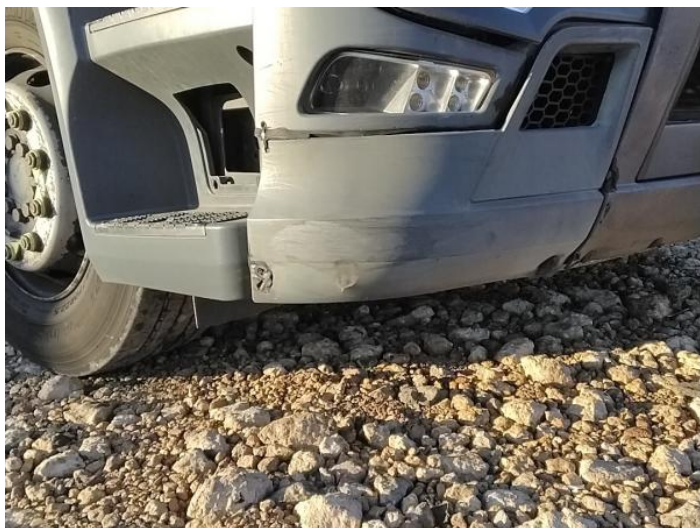
1: Bumper Front Moulding
Scuffed (Unpainted)
UpTo 100mm

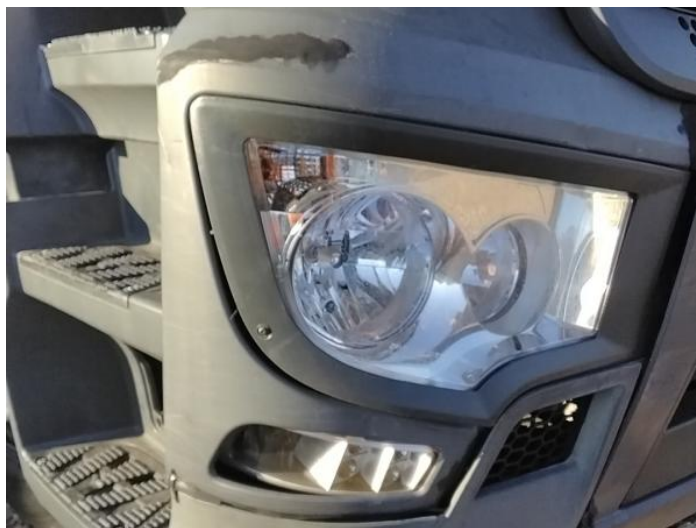
2: Fog Lamp Surround os
Scuffed (Unpainted)
UpTo 100mm

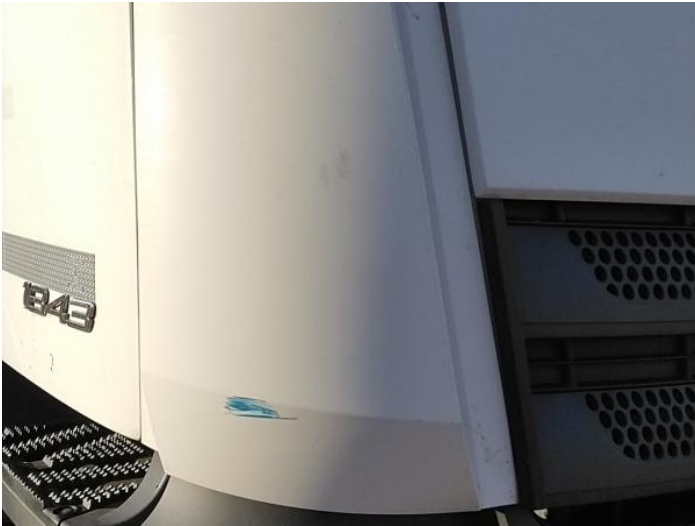
3: Wing osf
Scratched
UpTo 25mm Not Thru Paint

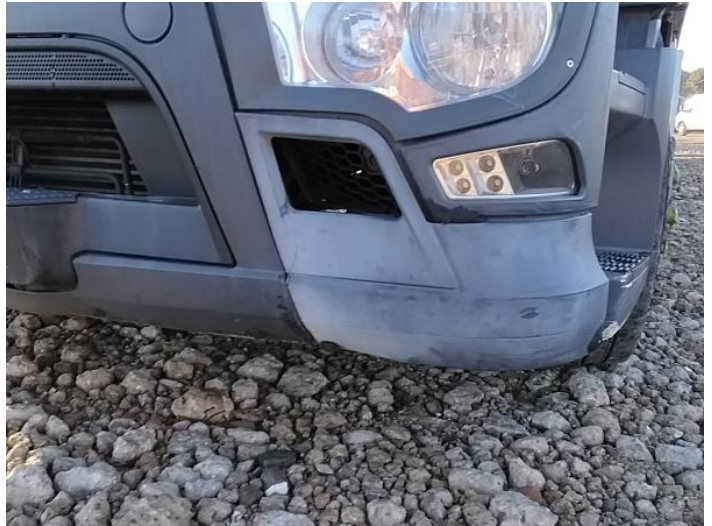
4: Bumper Front Moulding
Scuffed (Unpainted)
UpTo 100mm

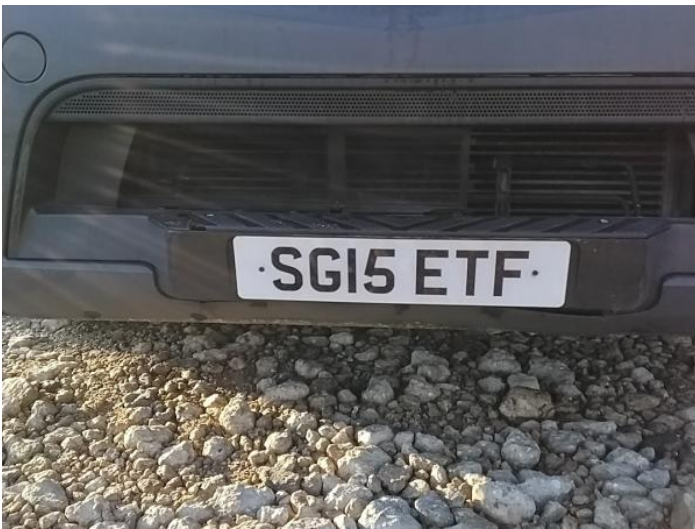
5: Grille Front
Broken
Replace

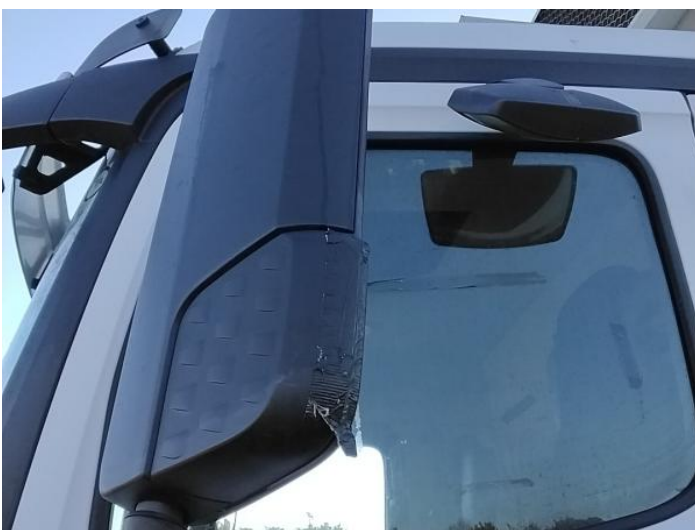
7: Door Mirror Assy nsf
Scuffed (Unpainted)
UpTo 100mm

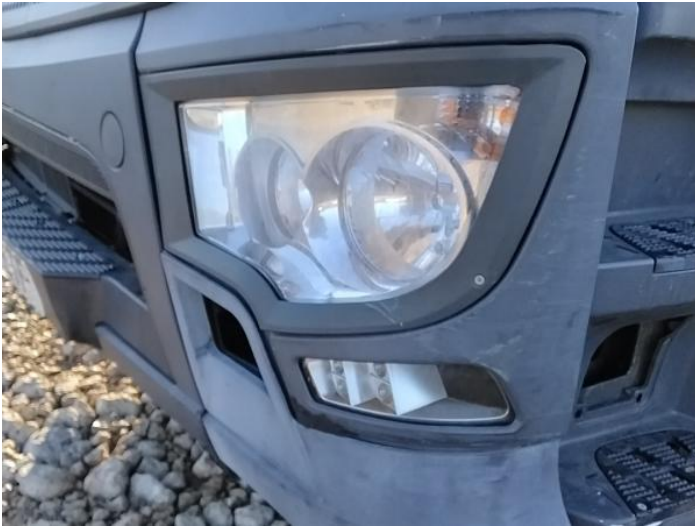
9: Fog Lamp Surround ns
Scuffed (Unpainted)
UpTo 100mm

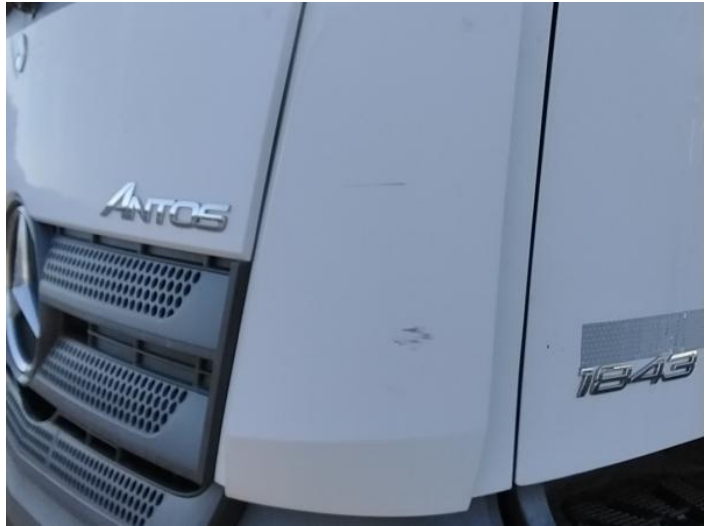
10: Wing nsf
Scratched
UpTo 25mm Not Thru Paint

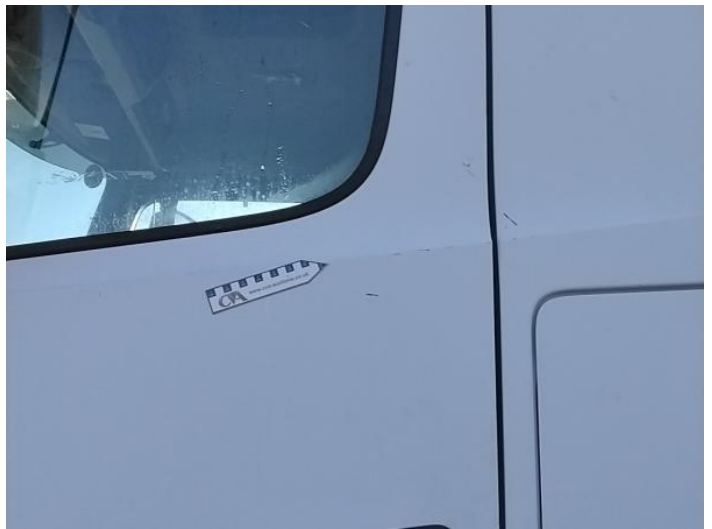
12: Door nsf
Scratched
UpTo 25mm Not Thru Paint

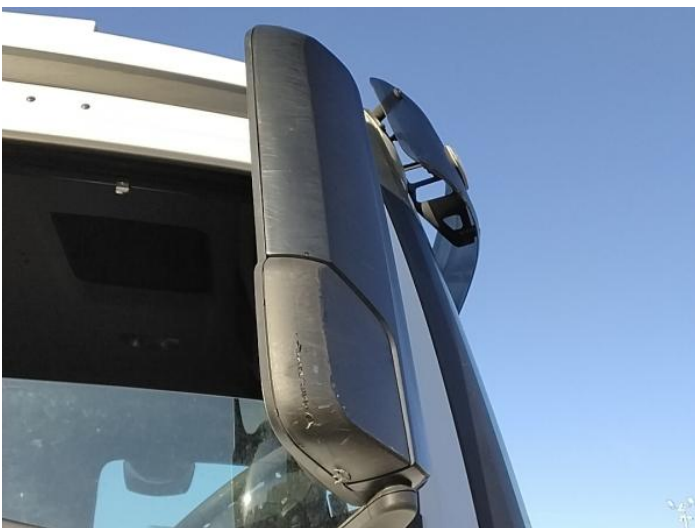
13: Door Mirror Assy osf
Scuffed (Unpainted)
UpTo 100mm

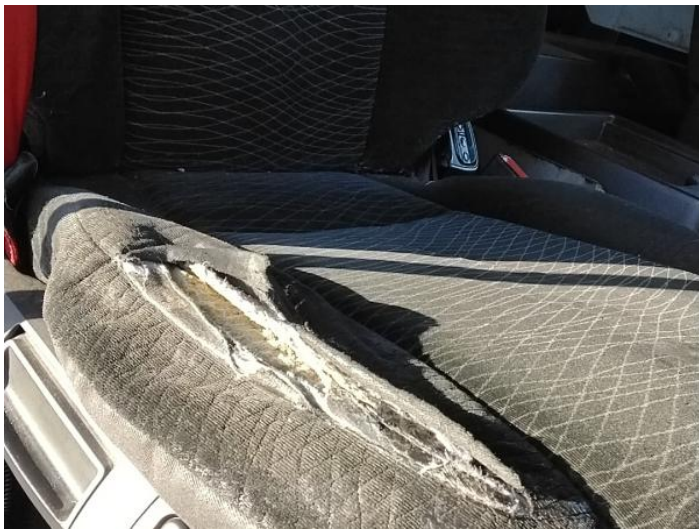
15: Seat Base Cover osf
Torn
Over 3mm
